Survey Area: Escambia County segments FLES1-035 and FLES2-008 (Fort Pickens NPS).

Survey Summary:

Monitoring Photos:

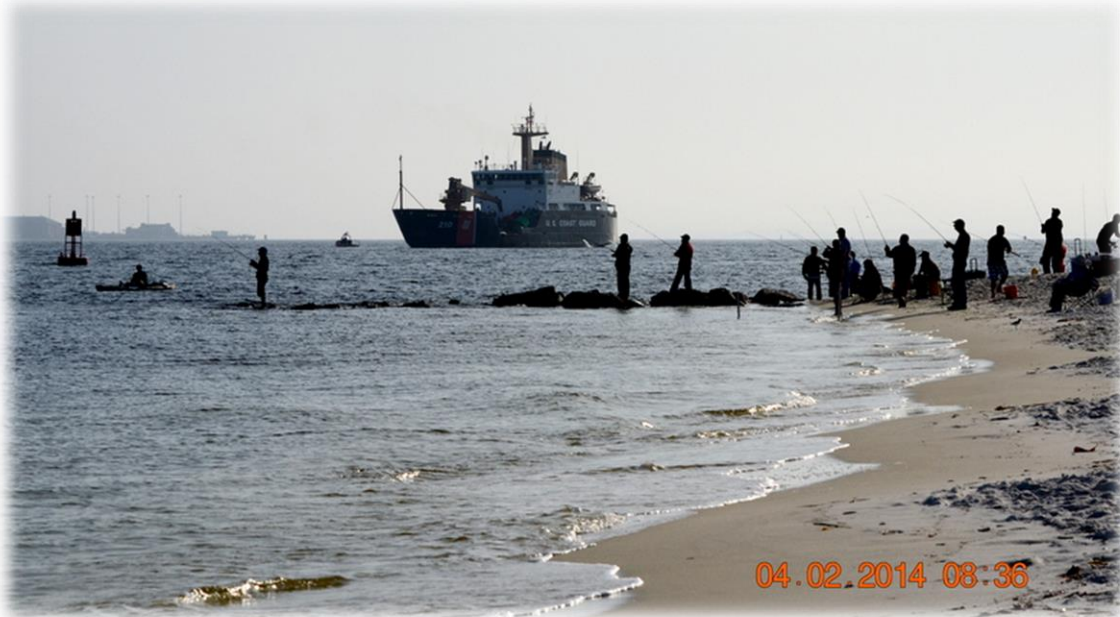
During today's survey the skies were sunny, with SE wind @ 5-10 knots, and the seas in the Gulf were 2 feet. The tide was mid and rising, with high tide (1.0 ft) at 11:23AM this morning and low tide (-0.08 ft) at 10:40 PM this evening.

Conditions at Fort Pickens

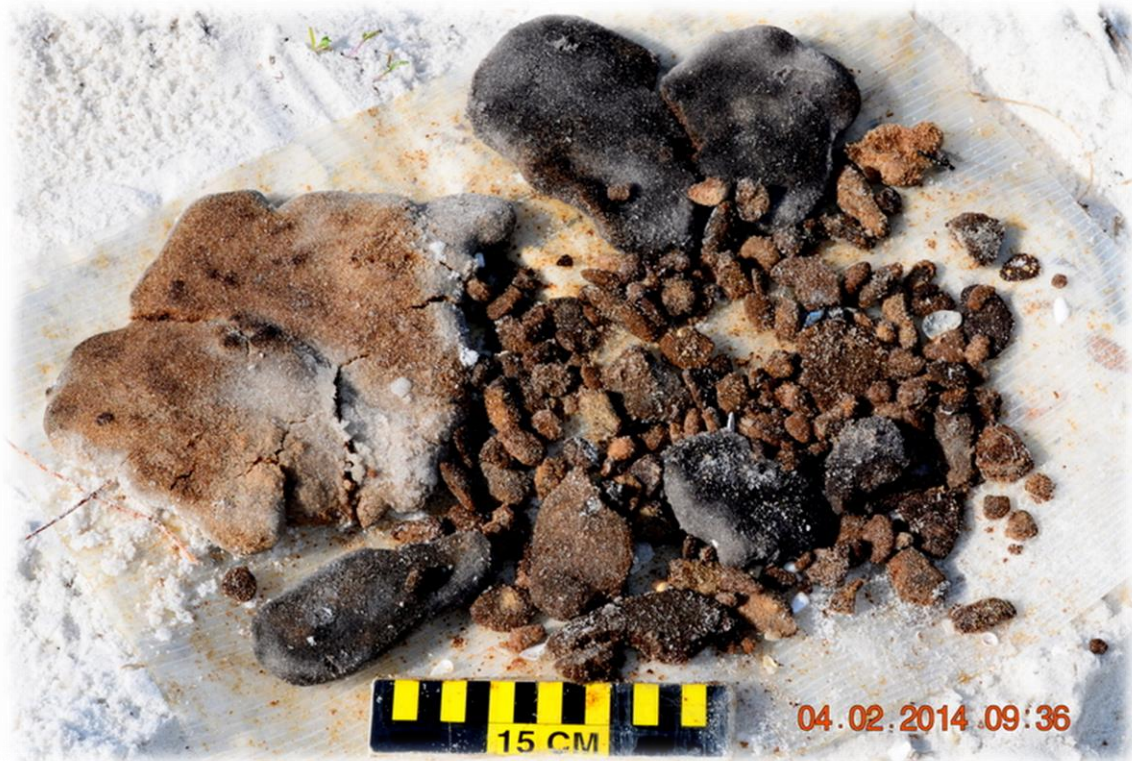
Today FDEP personnel conducted post-response monitoring surveys in Escambia County Divisions 1 and 2; segments FLES1-035 and FLES2-008. In segment FLES1-035 the majority of the oil was found in the STZ. The material was found in a chronic problem area where large pieces of oil uncover when the wind blows hard from the north. FDEP personnel mitigated some material from the segment but additional material remains to be addressed. A NRC report was filed for documentation.

SRBs/SRPs mitigated from FLES1-035

FLES2-008 and FLES1-035: Segments have been signed out of the response but continue to yield BP MC-252 material. Recommend further periodic monitoring when weather conditions are favorable for product recovery.

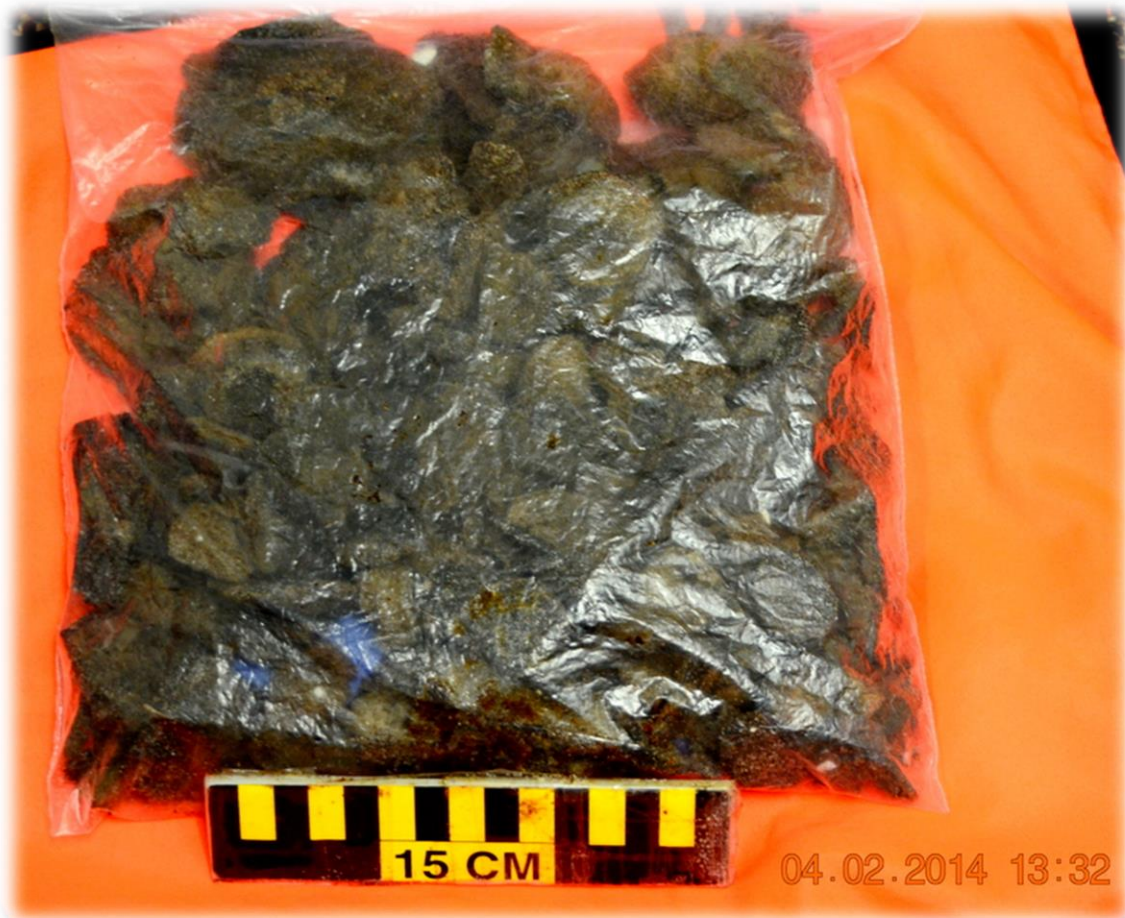
NPS personnel informed FDEP personnel of an area with critical bird nesting where many SRBs were observed. The park personnel later escorted the FDEP personnel to the area and numerous SRBs and 2 SRPs were found. Due to the proximity to the bird enclosure, SRB/SRP removal was expedited. The rest of the segment was not investigated. A NRC report was filed for documentation.

SRBs/SRP mitigated from FLES2-008
