Survey Area: Escambia County segments FLES2-018 and 019 (Pensacola Beach).

#### **Survey Summary:**

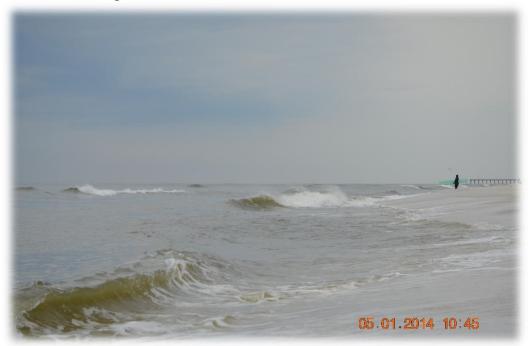
During today's survey the skies were cloudy, N wind @ 10 knots, and the seas in the Gulf were 2-3 feet. The tide was high and falling, with high tide (1.22 ft) at 10:48 AM this morning and low tide (-0.11 ft) at 10:38 PM tonight.

Conditions at Pensacola Beach

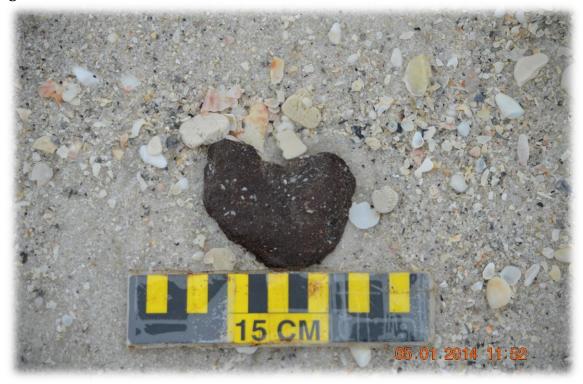
Example of SRB stranding in shell deposits in the ITZ

**FLES2-018 and 019:** Segments have been signed out of the response but continue to yield BP MC-252 material. Recommend further periodic monitoring when weather conditions are favorable for product recovery.

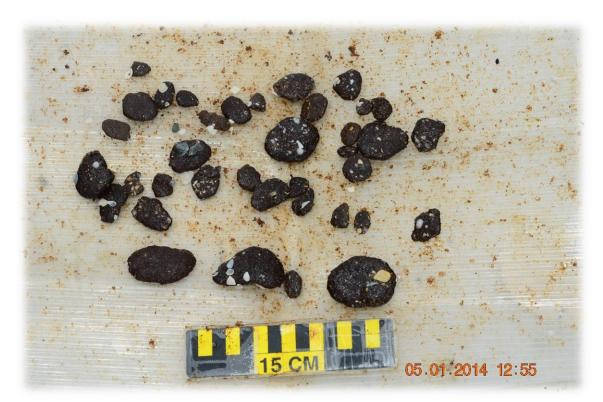
Segment ID	SRBs	SRB Size (cm)	SRB Weight (lb)	NRC Report #	NRC Followup
FLES2-018	40 1	1.00 - 5.25	0.43	1081446	USCG investigation
FLES2-019	67 <sup>1</sup>	1.25 - 9.25	1.55	1081446	USCG investigation

SRBs mitigated from FLES2-018

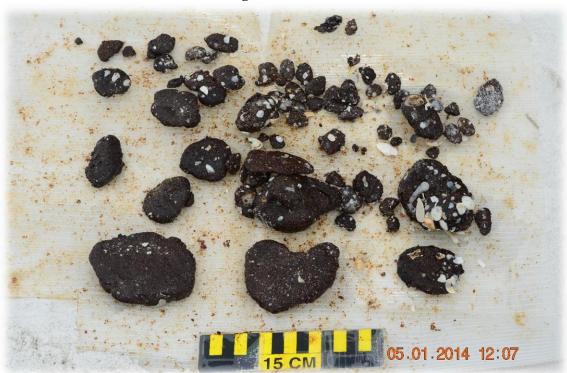
SRBs mitigated from FLES2-019
