Survey Area: Escambia County segment FLES1-021 (Johnson Beach NPS Perdido).

# **Survey Summary:**

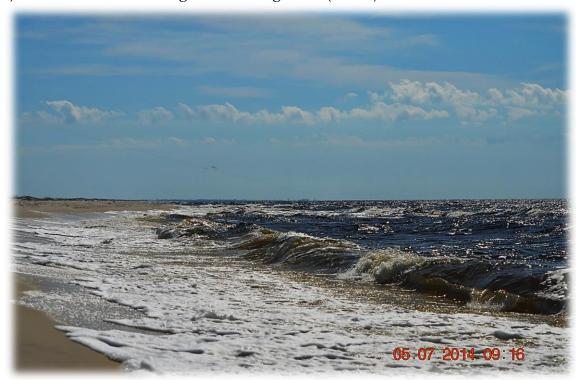
During today's survey there were mostly clear skies, winds were SE @ 5-10 knots, and the seas in the Gulf were 2 feet with waves breaking on shore. The tide was mid and rising today, with low tide (0.12 ft) at 1:54AM this morning and then high tide (0.80 ft) at 1:56 PM this afternoon.

Conditions at Johnson Beach

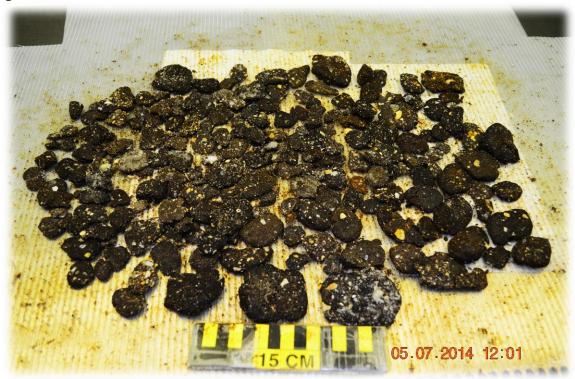
Segment ID	SRBs	SRB Size (cm)	SRB Weight (lb)	NRC Report #	NRC Followup
FLES1-021	204	1.50 - 7.00	2.25 +USCG 1.66	1082001	USCG mitigation

SRBs mitigated by FDEP from FLES1-021

**FLES1-021:** Segment has been signed out of the response but continues to yield BP MC-252 material. Recommend further periodic monitoring when weather conditions are favorable for product recovery.
